Claim #: CL89964-9

Summary Page

Address: 74 Strongberg Drive, Winnipeg,
MB, Canada

Vendor Name: Star Restoration

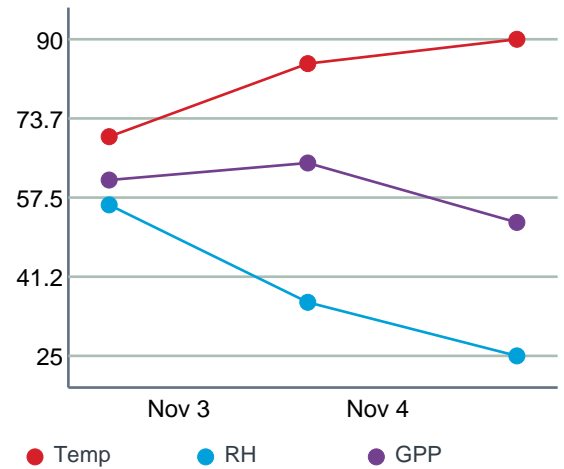
Affected Area

Date	Time	Room	Temp	RH	GPP
Nov 2, 2021	3:37 PM	Kitchen	70°F	56%	61.1 gpp
Notes: Link to photo					
Nov 3, 2021	3:34 PM	Kitchen	85°F	36%	64.6 gpp
Notes: Link to photo					
Nov 4, 2021	4:47 PM	Kitchen	90°F	25%	52.4 gpp
Notes: Link to photo

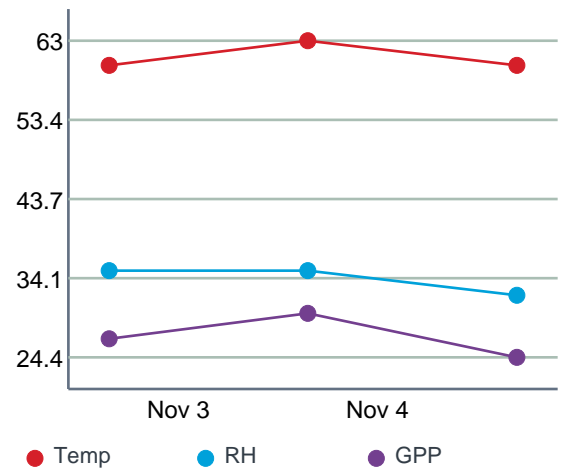
Affected Area HVAC

Date	Time	Room	Temp	RH	GPP
Nov 2, 2021	3:37 PM	Dining Room	60°F	35%	26.7 gpp
Notes: Link to photo					
Nov 3, 2021	3:35 PM	Dining Room	63°F	35%	29.8 gpp
Notes: Link to photo					
Nov 4, 2021	4:48 PM	Dining Room	60°F	32%	24.4 gpp
Notes: Link to photo

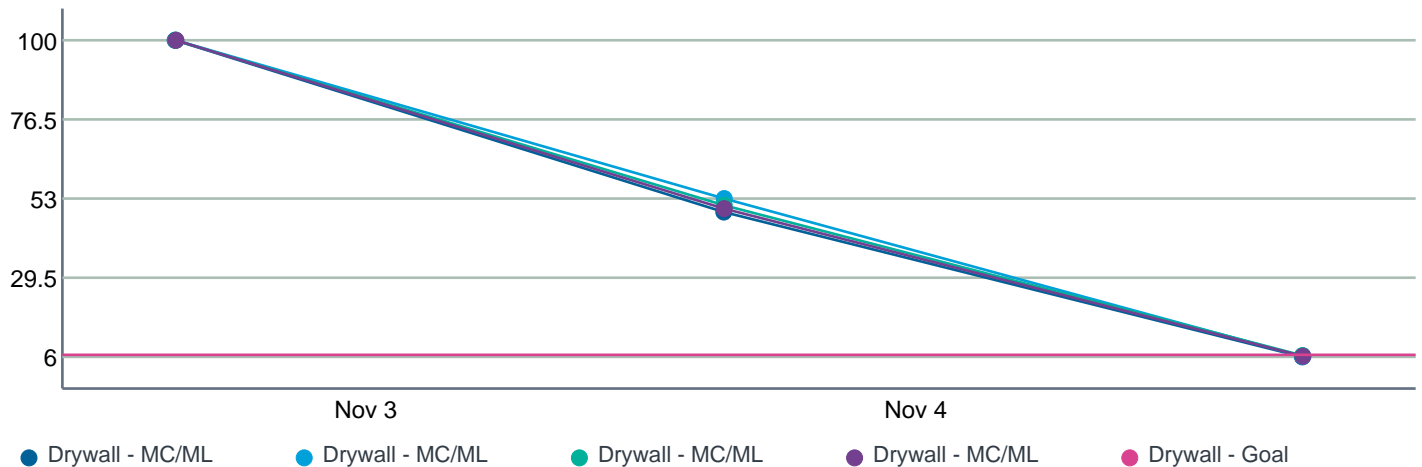
Moisture Point Readings for Kitchen

MP	Material	Reading	Goal	To Go	Temp	Date	Time	Notes
1	Drywall	100%	6.6%	93.4%		Nov 2, 2021	3:41 PM	Link to photo
1	Drywall	49%	6.6%	42.4%		Nov 3, 2021	3:37 PM	Link to photo
1	Drywall	6%	6.6%	0%		Nov 4, 2021	4:51 PM	DRY - Link to photo
2	Drywall	100%	6.6%	93.4%		Nov 2, 2021	3:42 PM	Link to photo
2	Drywall	53%	6.6%	46.4%		Nov 3, 2021	3:38 PM	Link to photo
2	Drywall	6.1%	6.6%	0%		Nov 4, 2021	4:52 PM	DRY - Link to photo
3	Drywall	100%	6.6%	93.4%		Nov 2, 2021	3:42 PM	Link to photo
3	Drywall	51%	6.6%	44.4%		Nov 3, 2021	3:38 PM	Link to photo
3	Drywall	6.4%	6.6%	0%		Nov 4, 2021	4:51 PM	DRY - Link to photo
4	Drywall	100%	6.6%	93.4%		Nov 2, 2021	3:43 PM	Link to photo
4	Drywall	50%	6.6%	43.4%		Nov 3, 2021	3:38 PM	Link to photo
4	Drywall	6.2%	6.6%	0%		Nov 4, 2021	4:52 PM	DRY - Link to photo

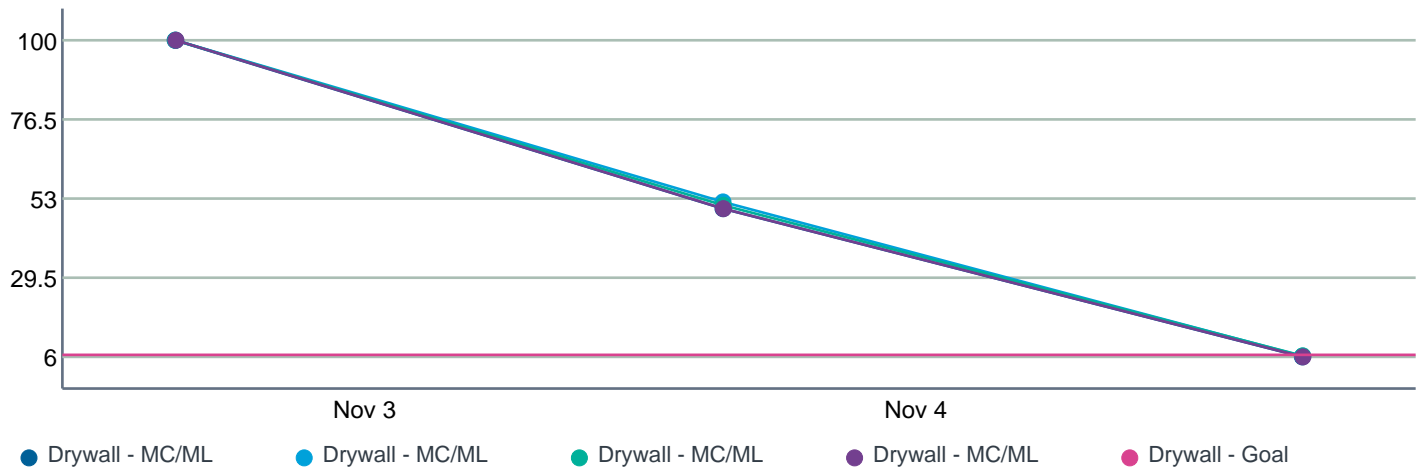
Moisture Point Readings for Dining Room

MP	Material	Reading	Goal	To Go	Temp	Date	Time	Notes
1	Drywall	100%	6.6%	93.4%		Nov 2, 2021	3:45 PM	Link to photo
1	Drywall	50%	6.6%	43.4%		Nov 3, 2021	3:36 PM	Link to photo
1	Drywall	6%	6.6%	0%		Nov 4, 2021	4:49 PM	DRY - Link to photo
2	Drywall	100%	6.6%	93.4%		Nov 2, 2021	3:46 PM	Link to photo
2	Drywall	52%	6.6%	45.4%		Nov 3, 2021	3:36 PM	Link to photo
2	Drywall	6.2%	6.6%	0%		Nov 4, 2021	4:49 PM	DRY - Link to photo
3	Drywall	100%	6.6%	93.4%		Nov 2, 2021	3:46 PM	Link to photo
3	Drywall	51%	6.6%	44.4%		Nov 3, 2021	3:37 PM	Link to photo
3	Drywall	6.3%	6.6%	0%		Nov 4, 2021	4:50 PM	DRY - Link to photo
4	Drywall	100%	6.6%	93.4%		Nov 2, 2021	3:47 PM	Link to photo
4	Drywall	50%	6.6%	43.4%		Nov 3, 2021	3:37 PM	Link to photo
4	Drywall	6%	6.6%	0%		Nov 4, 2021	4:50 PM	DRY - Link to photo
