## Policyholder

## Claim Details

<b>Carrier Identifier</b>	<b>Contractor Identifier</b>	<b>Assignment Identifier</b>
CL89964-9	001-102121	--
<b>Project Manager</b>	<b>Date of Loss</b>	<b>Date Claim Created</b>
--	Oct 21, 2021	Oct 27, 2021
<b>Insurance Company</b>	<b>Adjuster</b>	<b>Policy Number</b>
Allstate	--	1136JH97
<b>Source of Loss</b>	<b>Initial Category of Water</b>	
Broken supply line	Category 1

# Drying Chamber: Main Floor

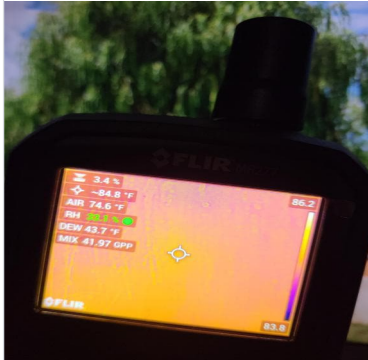
#	Time	Relative Humidity	Specific Humidity	Air Temperature	Notes & Photos
1	Nov 2, 3:33 PM	36%	39.1 gpp	70°F	Back yard

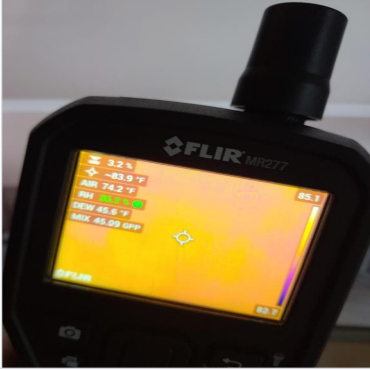
#	Time	Room	Relative Humidity	Specific Humidity	Air Temperature	Notes & Photos
3	Nov 4, 4:46 PM	Bedroom - Master	34%	42.3 gpp	74°F

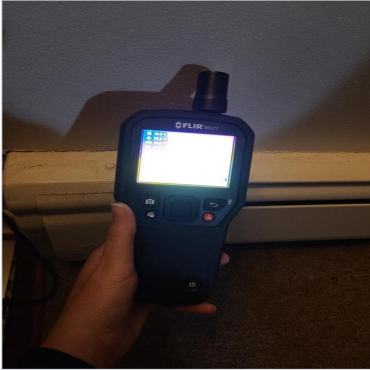
#	Time	Room	Relative Humidity	Specific Humidity	Air Temperature	Notes & Photos
1	Nov 2, 3:35 PM	Bedroom - Master	38%	29.1 gpp	60°F

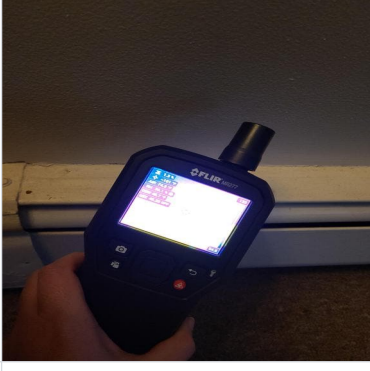
3	Nov 4, 4:46 PM	Bedroom - Master	34%	26 gpp	60°F

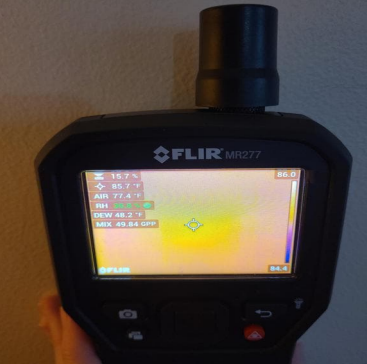
#	Time	Meter	Moisture Content	Surface Temperature	Notes & Photos
2	Nov 3, 3:37 PM	Flir 100%	49%

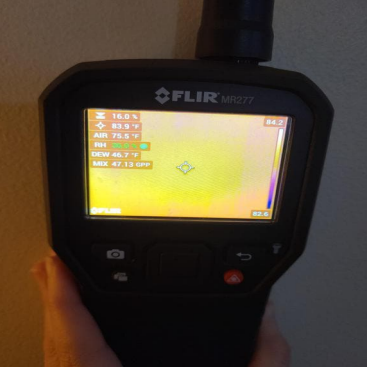
3	Nov 4, 4:51 PM	Flir 100%	6%

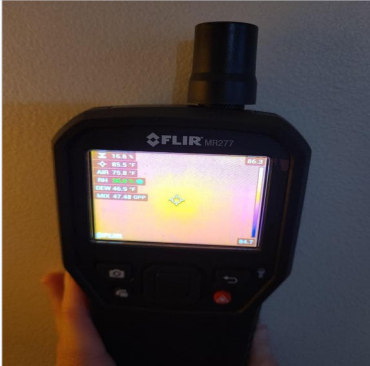
**Point 2: Moisture Point 2**

#	Time	Meter	Moisture Content	Surface Temperature	Notes & Photos
3	Nov 4, 4:52 PM	Flir 100%	6.1%

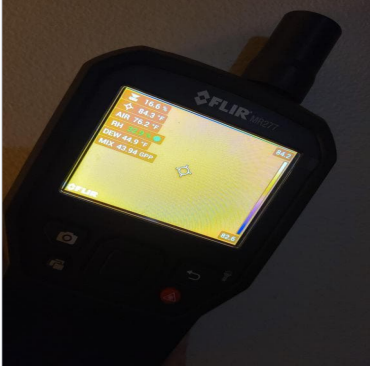
**Point 3: Moisture Point 3**

#	Time	Meter	Moisture Content	Surface Temperature	Notes & Photos
1	Nov 2, 3:42 PM	Flir 100%	100%

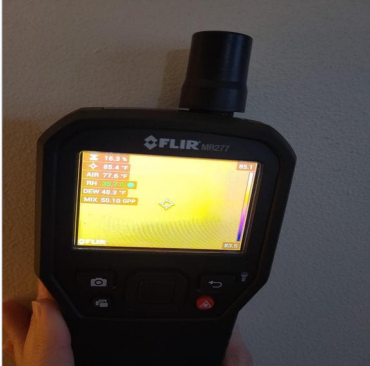
2	Nov 3, 3:38 PM	Flir 100%	51%

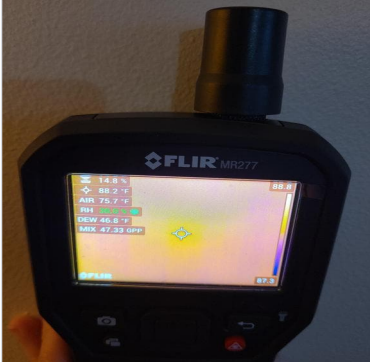
3	Nov 4, 4:51 PM	Flir 100%	6.4%

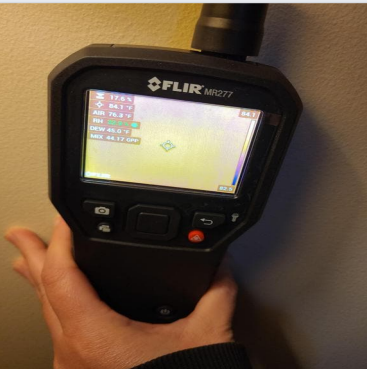
Point 4: Moisture Point 4

#	Time	Meter	Moisture Content	Surface Temperature	Notes & Photos
1	Nov 2, 3:43 PM	Flir 100%	100%

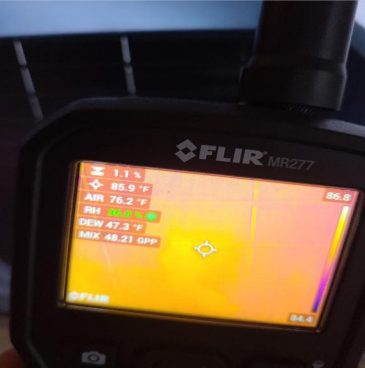
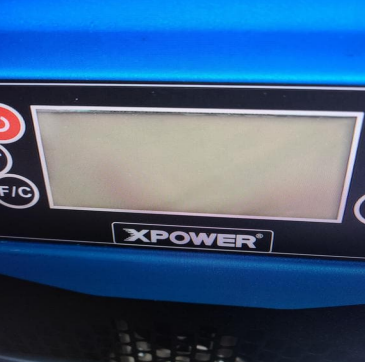
**Dehumidifier: XPower XD-85L (DH-001)**

#	Time	Relative Humidity	Specific Humidity	Air Temperature	Grain Depression	Hours Running	Notes & Photos
3	Nov 4, 4:54 PM	7%	17 gpp	95°F	35 gpp	72.50 hrs

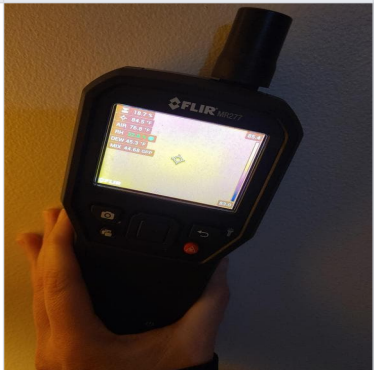
Point 1: Moisture Point 1

#	Time	Meter	Moisture Content	Surface Temperature	Notes & Photos
1	Nov 2, 3:45 PM	Flir 100%	100%

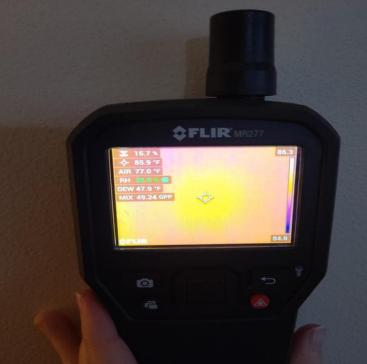
#	Time	Meter	Moisture Content	Surface Temperature	Notes & Photos
2	Nov 3, 3:36 PM	Flir 100%	50%

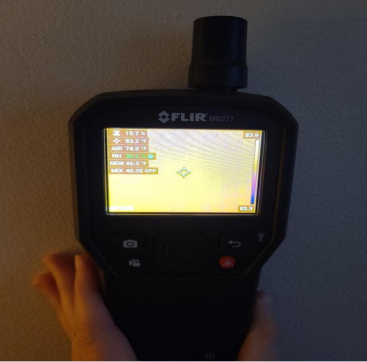
3	Nov 4, 4:49 PM	Flir 100%	6%

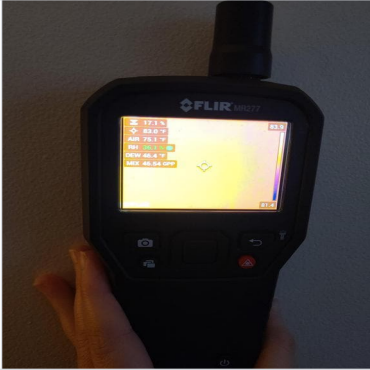
**Point 2: Moisture Point 2**

#	Time	Meter	Moisture Content	Surface Temperature	Notes & Photos
3	Nov 4, 4:49 PM	Flir 100%	6.2%
