Claim #: CL89964-9

Summary Page

Address: 74 Strongberg Drive, Winnipeg,
MB, Canada

Vendor Name: Star Restoration

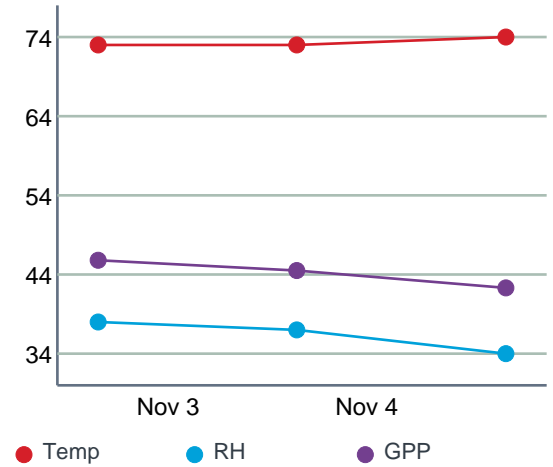
Psychrometric Readings (Unaffected)

Date	Time	Room	Temp	RH	GPP
Nov 2, 2021	3:34 PM	Bedroom - Master	73°F	38%	45.8 gpp
Notes: Link to photo					
Nov 3, 2021	3:32 PM	Bedroom - Master	73°F	37%	44.5 gpp
Notes: Link to photo					
Nov 4, 2021	4:46 PM	Bedroom - Master	74°F	34%	42.3 gpp
Notes: Link to photo

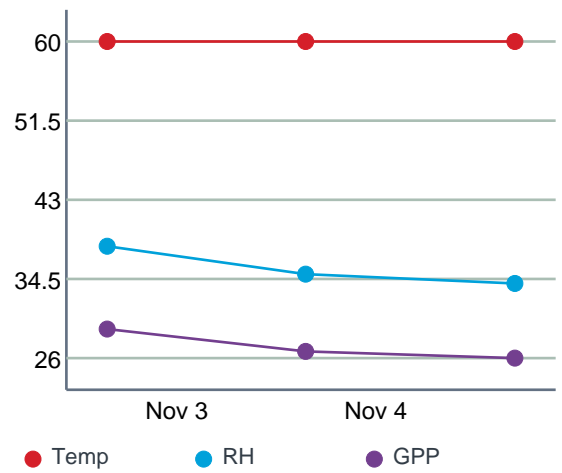
Psychrometric Readings (Unaffected HVAC)

Date	Time	Room	Temp	RH	GPP
Nov 2, 2021	3:35 PM	Bedroom - Master	60°F	38%	29.1 gpp
Notes: Link to photo					
Nov 3, 2021	3:32 PM	Bedroom - Master	60°F	35%	26.7 gpp
Notes: Link to photo					
Nov 4, 2021	4:46 PM	Bedroom - Master	60°F	34%	26 gpp
Notes: Link to photo
