Policyholder

Claim Details

Carrier Identifier	Contractor Identifier	Assignment Identifier
CL89964-9	001-102121	--
Project Manager	Date of Loss	Date Claim Created
--	Oct 21, 2021	Oct 27, 2021
Insurance Company	Adjuster	Policy Number
Allstate	--	1136JH97
Source of Loss	Initial Category of Water	
Broken supply line	Category 1

Drying Chamber: Main Floor

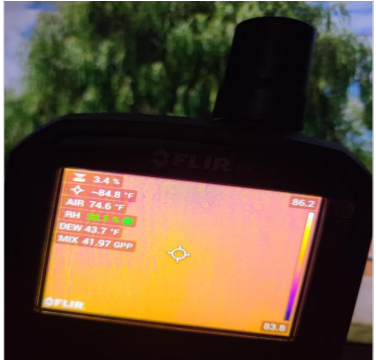
#	Time	Relative Humidity	Specific Humidity	Air Temperature	Notes & Photos
1	Nov 2, 3:33 PM	36%	39.1 gpp	70°F	Back yard

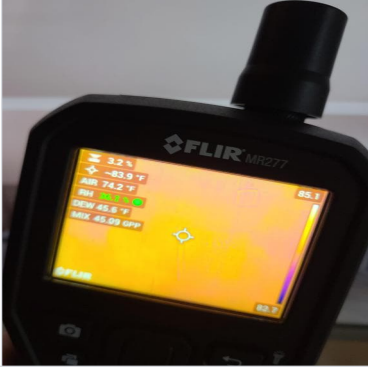
#	Time	Room	Relative Humidity	Specific Humidity	Air Temperature	Notes & Photos
3	Nov 4, 4:46 PM	Bedroom - Master	34%	42.3 gpp	74°F

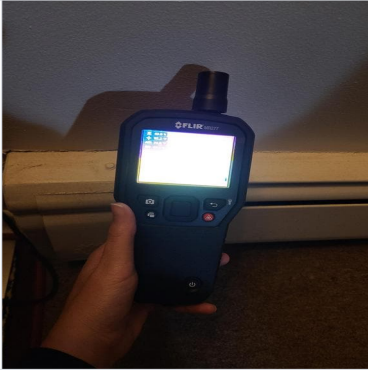
#	Time	Room	Relative Humidity	Specific Humidity	Air Temperature	Notes & Photos
1	Nov 2, 3:35 PM	Bedroom - Master	38%	29.1 gpp	60°F

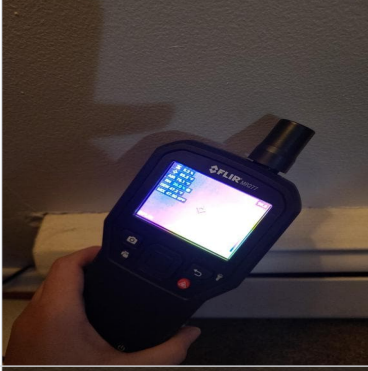
2	Nov 3, 3:32 PM	Bedroom - Master	35%	26.7 gpp	60°F

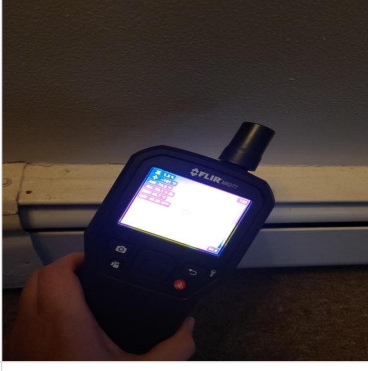
3	Nov 4, 4:46 PM	Bedroom - Master	34%	26 gpp	60°F

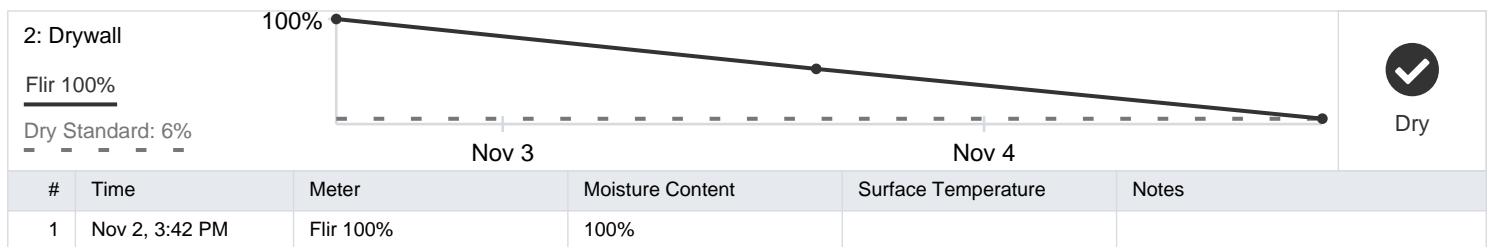
Point 2: Moisture Point 2

#	Time	Meter	Moisture Content	Surface Temperature	Notes
2	Nov 3, 3:38 PM	Flir 100%	53%		
3	Nov 4, 4:52 PM	Flir 100%	6.1%

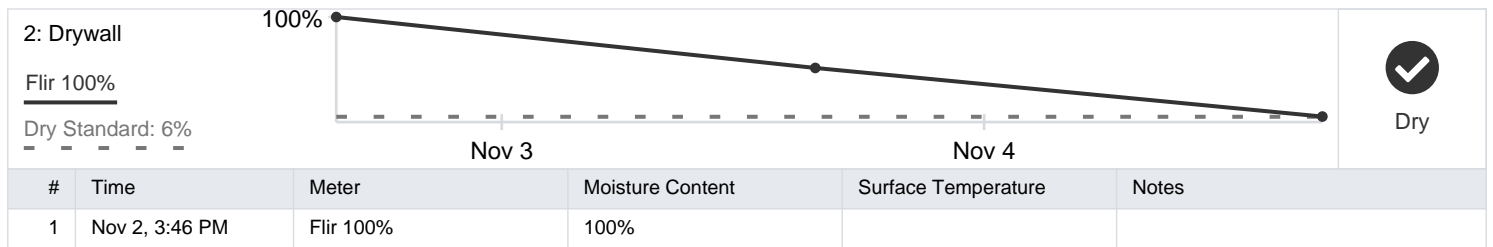
Point 2: Moisture Point 2

#	Time	Meter	Moisture Content	Surface Temperature	Notes
2	Nov 3, 3:36 PM	Flir 100%	52%		
3	Nov 4, 4:49 PM	Flir 100%	6.2%
